An Application of Autonomous Vehicles to Manage High-Risk Exposure in Geothermal Operations

Hannah Martin¹, Ben Gibson¹, Emily Collis¹, Steven Gray¹, Craig Martin-Smith² and Johan Potgieter²

¹Mercury, Rotokawa Power Station, 162 Rapids Road, RD2, Taupō, 3378, New Zealand

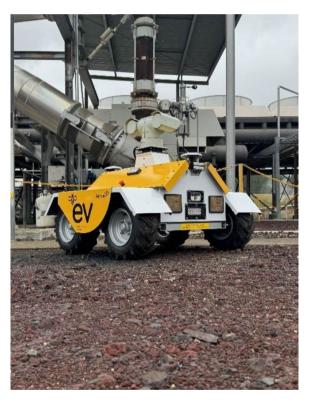
The first iteration autonomous inspection vehicle (known as M1) shown in Figure 1, was designed and built by Wrybill Robotics based in Palmerston North, New Zealand. The first use of M1 was at Mercury's Rotokawa site. M1 undertook a small, repeated route to test the reliability of the autonomous function. It was important to check the vehicle would reliably stay on its autonomous path due to presence of pentane at Rotokawa, and when objects were detected, it would avoid collision by stopping.

Figure 1: Autonomous Inspection Vehicle at Mercury's Rotokawa Geothermal Site

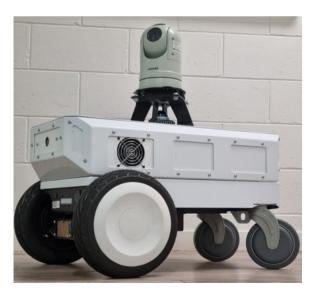
Once Wi-Fi and access points are confirmed, indoor autonomous inspection vehicles (Figure 5) will be implemented at Mercury's Ohakurī hydro station on the Waikato River.

The indoor AIV's use Simultaneous Localisation and Mapping (SLAM) with 3D LiDAR to localise against a prerecorded map. Scan matching algorithms (e.g. Iterative Closest Point) align live point clouds with the recorded map.

These AIV have infrastructure independence, so no reliance on GPS. The AIV has a function to assist with drift correction – the more the AIV completes its planned route, the more precise it will get about its position overtime due to building a more accurate map.

Figure 5: Indoor Autonomous Inspection Vehicle
